**AN ASSESSMENT OF  
STORMWATER MANAGEMENT  
RETROFIT AND  
STREAM RESTORATION  
OPPORTUNITIES IN  
BALLENGER CREEK WATERSHED,  
FREDERICK COUNTY,  
MARYLAND**

**Frederick County  
Division of Public Works  
118 North Market Street  
Frederick, Maryland 21701-5422**

**Versar, Inc.  
9200 Rumsey Road  
Columbia, Maryland 21045**

**August 2005**

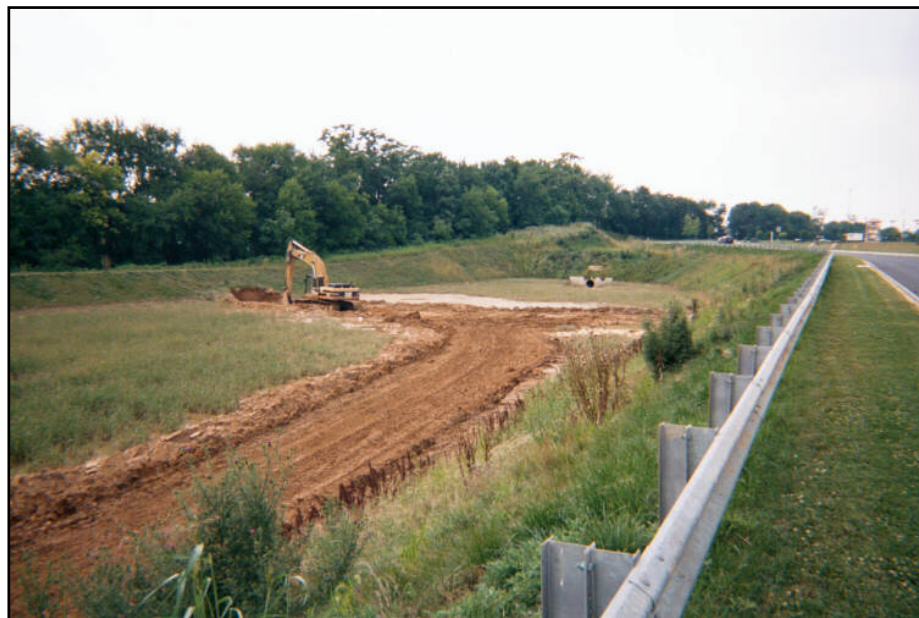
Figure 1-2. Sinkhole repair in the bottom of a stormwater management facility, Gilford Road across from Wal-Mart, July 2000.

Compounding the effects of urbanization, limestone geology underlying the eastern portions of the watershed is easily dissolved by both groundwater and stormwater infiltration. When the underlying limestone bedrock is dissolved, changes in groundwater elevation brought on by drought, groundwater withdraw, and other hydrologic modifications can result in surface collapse, forming karst features such as sinkholes and depressions (Figure 1-2). Additionally, karst geology can result in disappearing streams, intermittent streamflow, and rapid infiltration of surface water (which may contain pollutants) into underlying aquifers.
